Structure

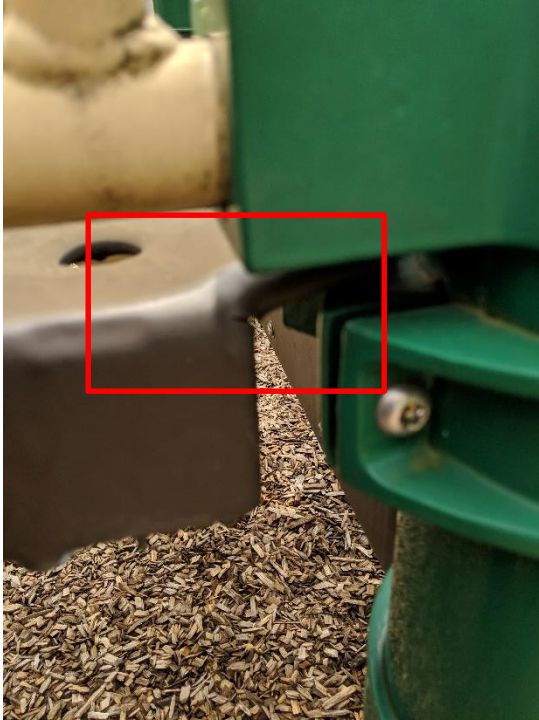
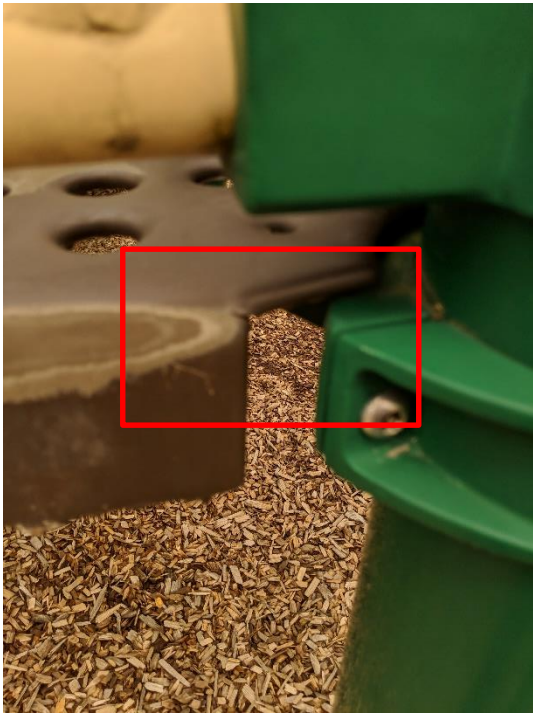
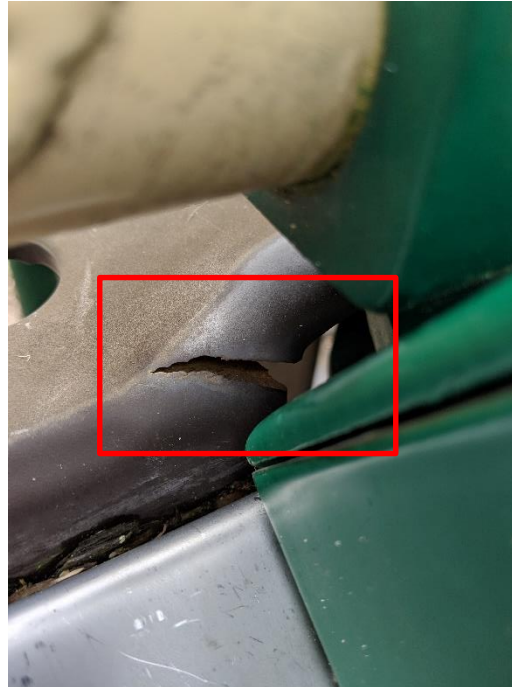
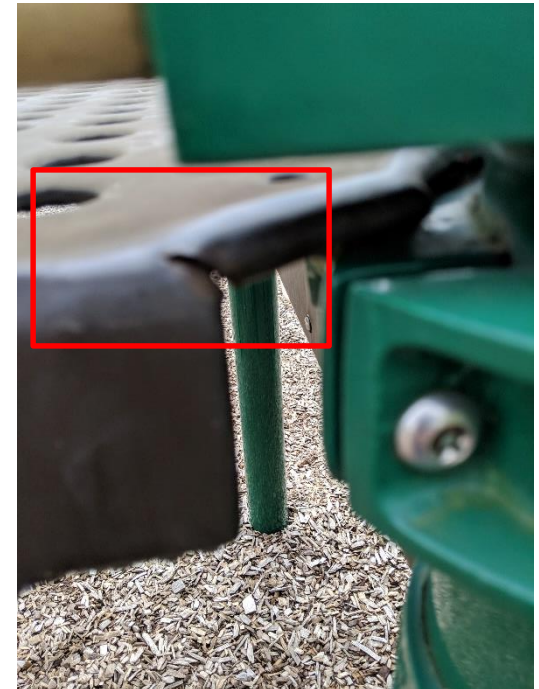
1. Decks cracking Recommend replacement. Cracking will continue to expand. Steel unprotected. Monitor closely
 1. Priority 3.

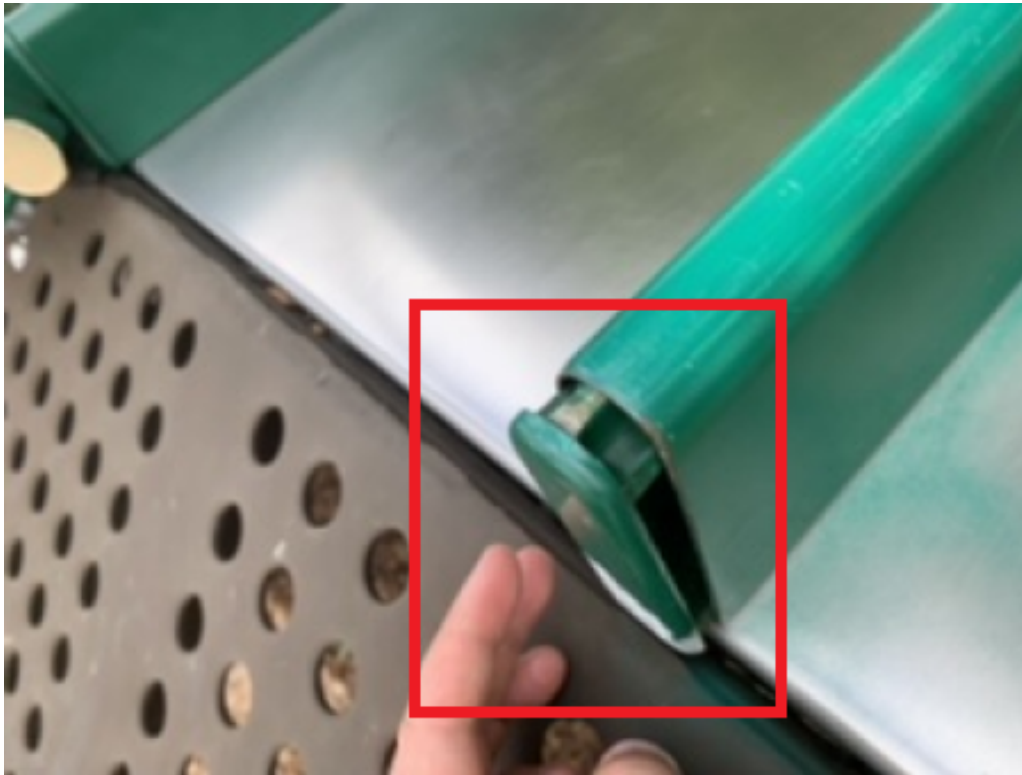
1. Rail cap is loose and can easily be removed. If removed, this will cause a Priority 1 entanglement hazard. Recommend secure to slide rail using manufacturer recommendations
 1. Priority 4

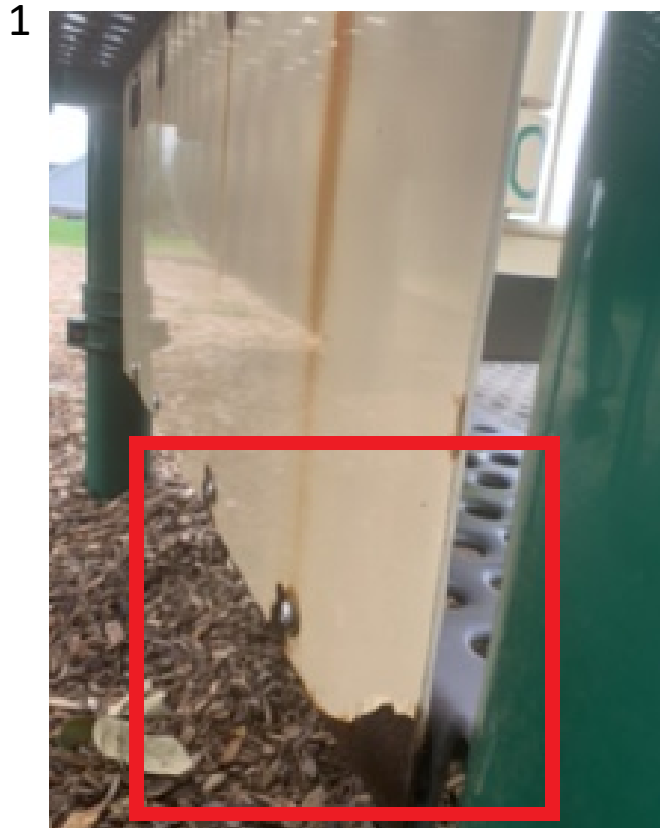
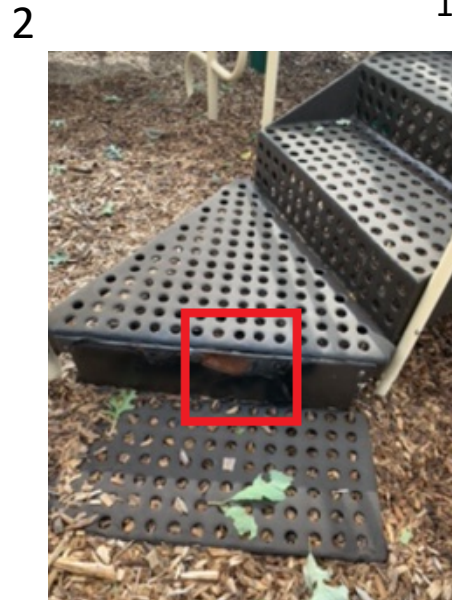
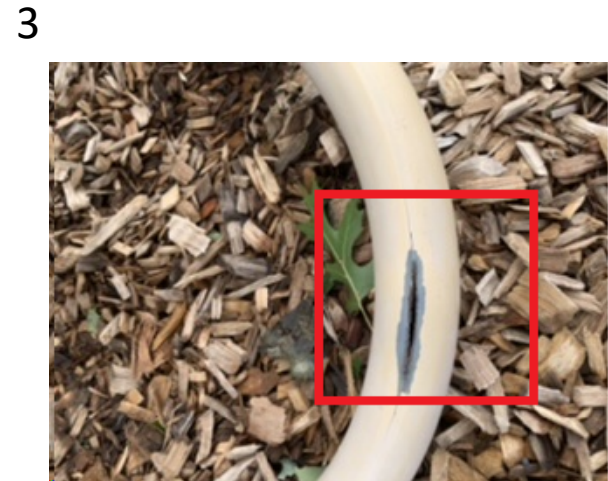
1. PVC coating missing. Replace step. Steel rusting
 1. Priority 4
2. Rust and sharp edges on panels under decks. Needs replaced
 1. Priority 2
3. Twist climber is broken at base exposing metal edges. Needs replaced
 1. Priority 4

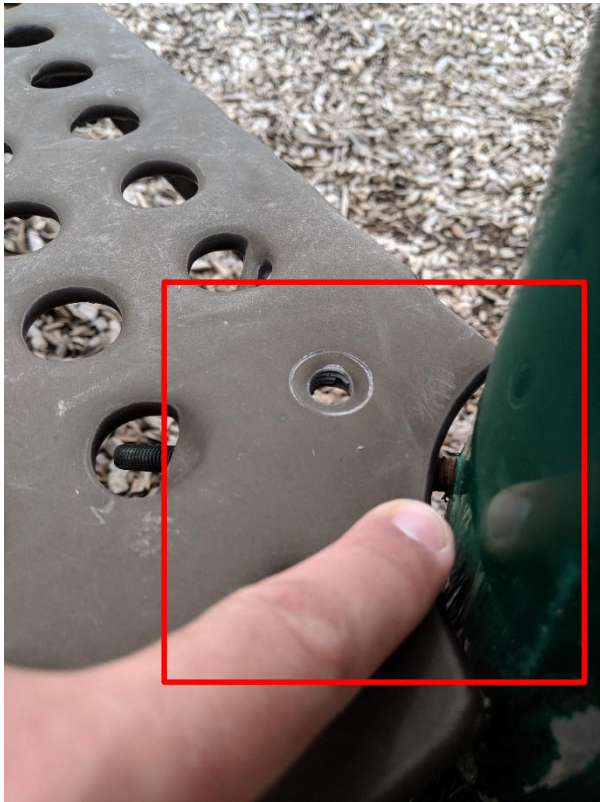
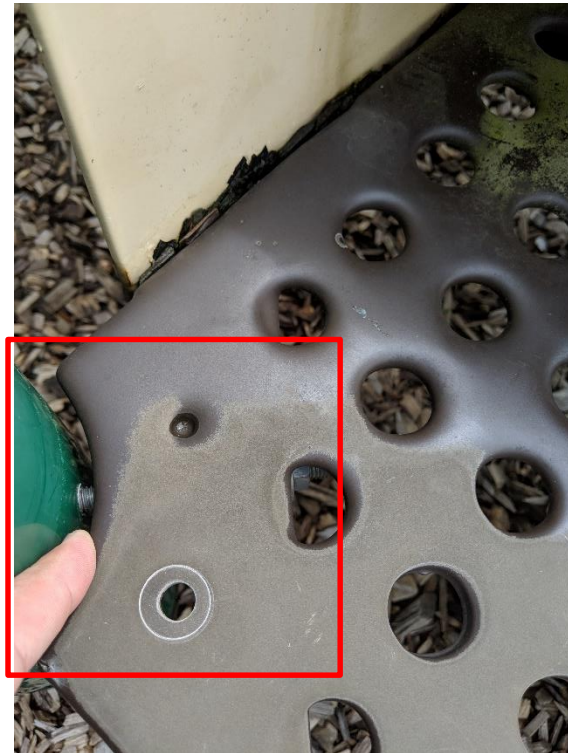
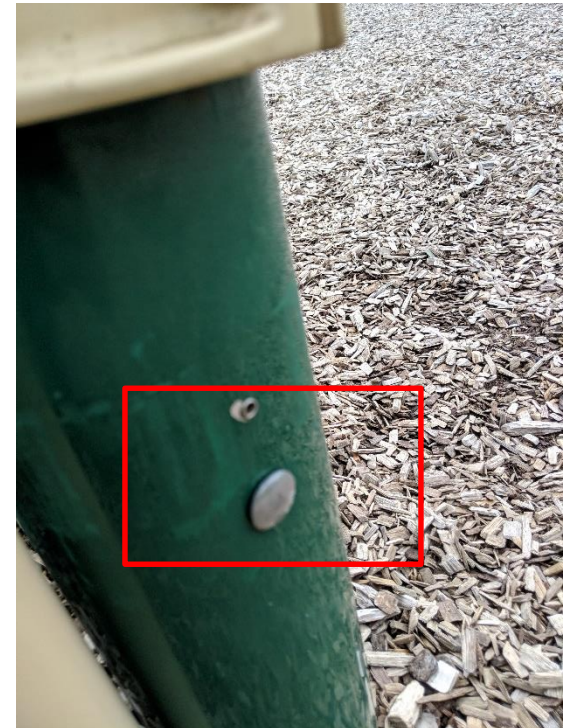
1. Lower Deck Clamps missing. Aftermarket fastner used. Not recommended. Replace with OEM components only
 1. Priority 3

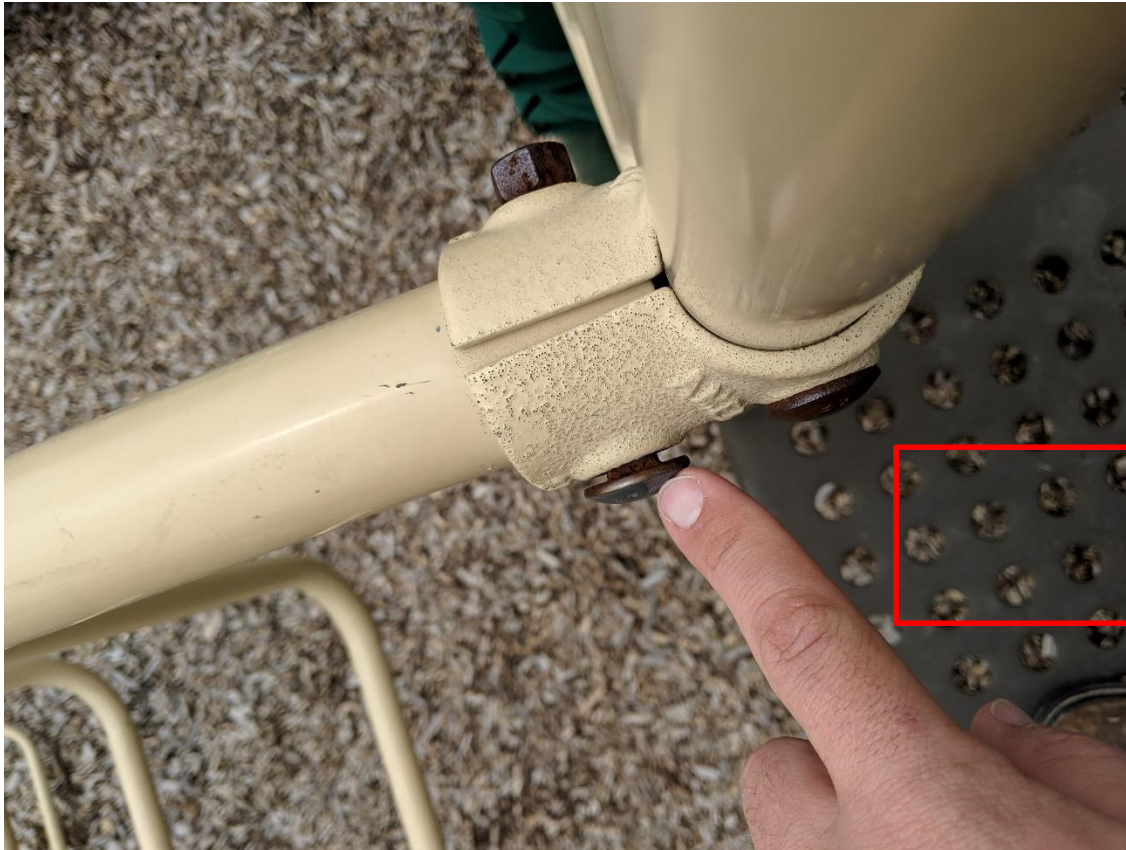
1. Carriage bolt head Must be flush. Entanglement hazard
 1. Priority 1

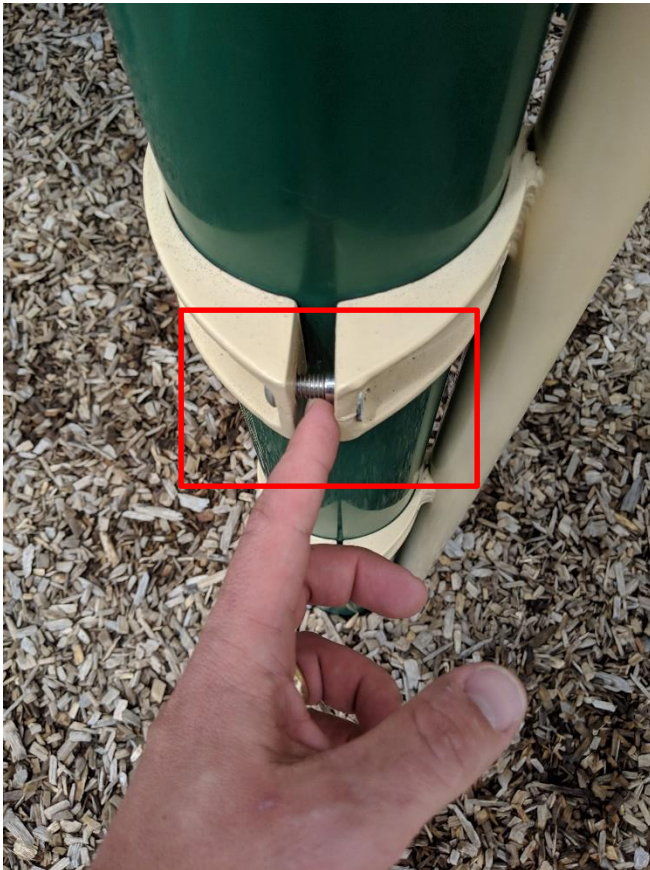
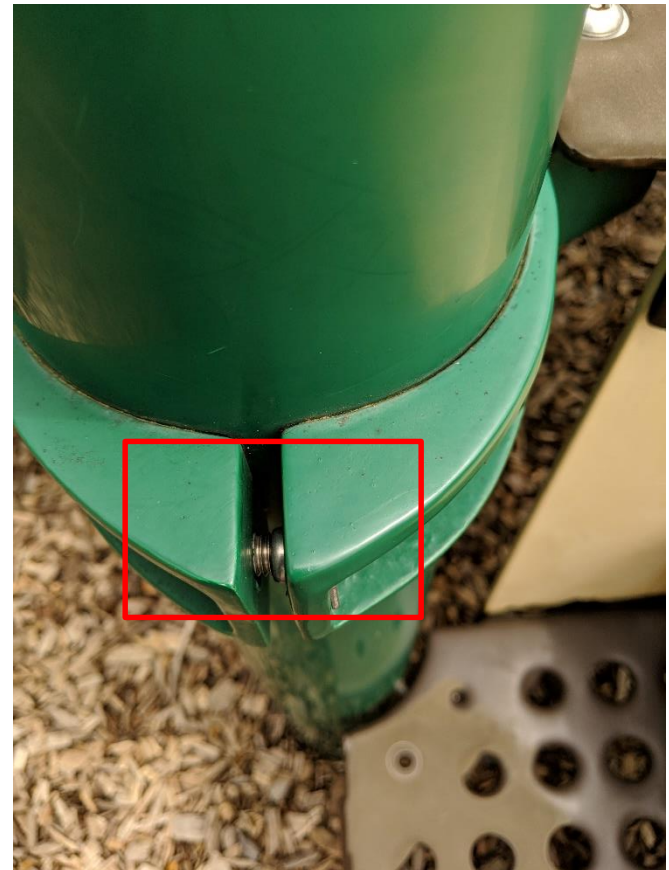
1

1. Clamps tightened unevenly. Recommend retighten of all clamps
 1. Priority 4

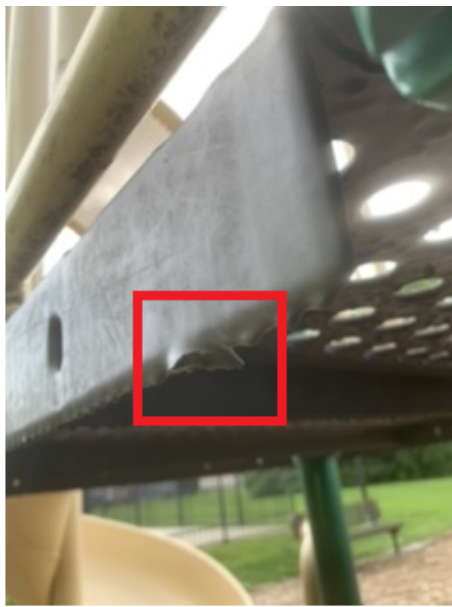
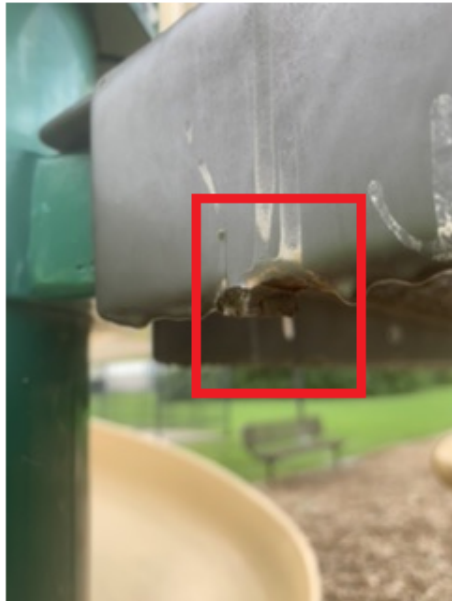
1. Decks have sharp edges underneath. Replace decks
1. Priority 2

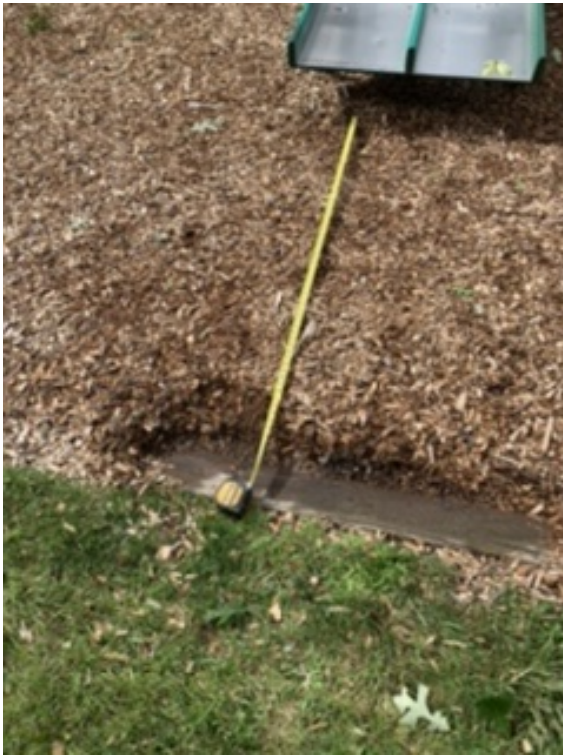
1. Safety Zone required is 6ft. Border timber encroaches safety zone making it less than 6ft. Border needs relocated 1. Priority 4

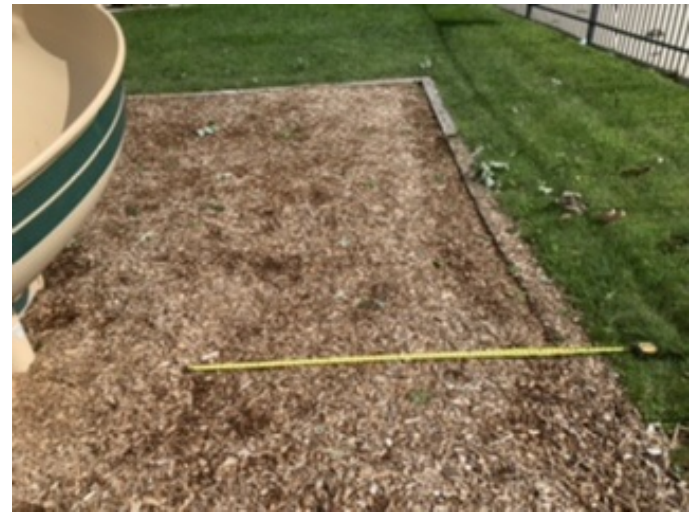
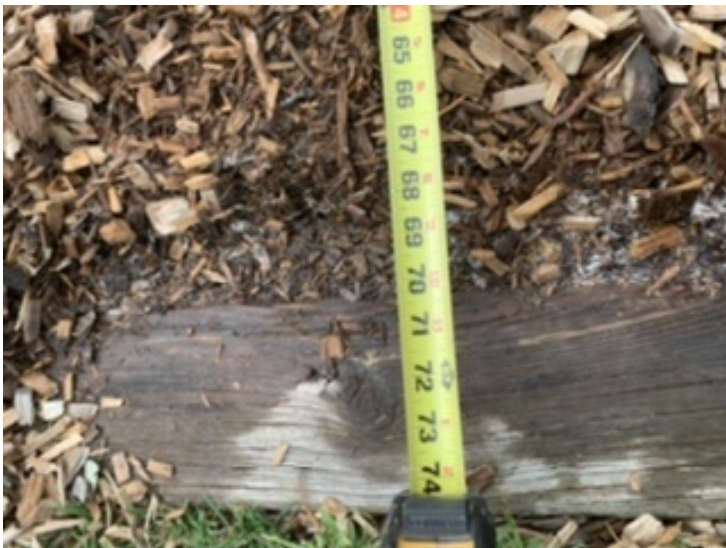
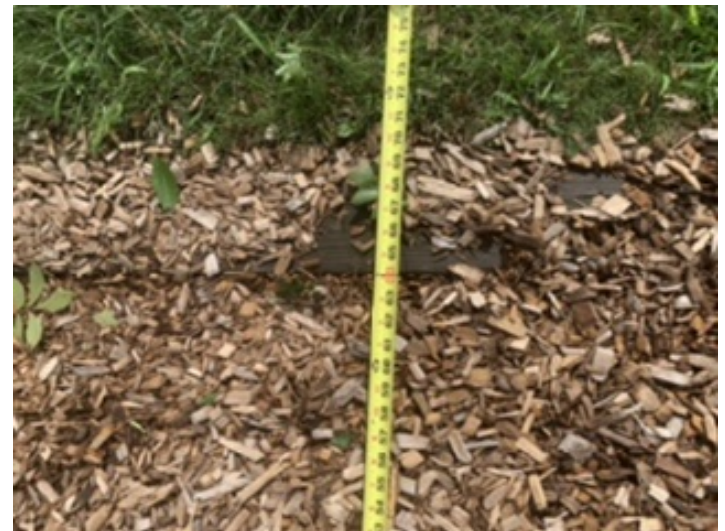
1. Mulch needed. Recommend swing mats
 1. Priority 2
2. S hook must be closed
 1. Priority 2
3. Swing seat connection points starting to wear. Replace with new chains and seats (10')
 1. Priority 4
