Structure

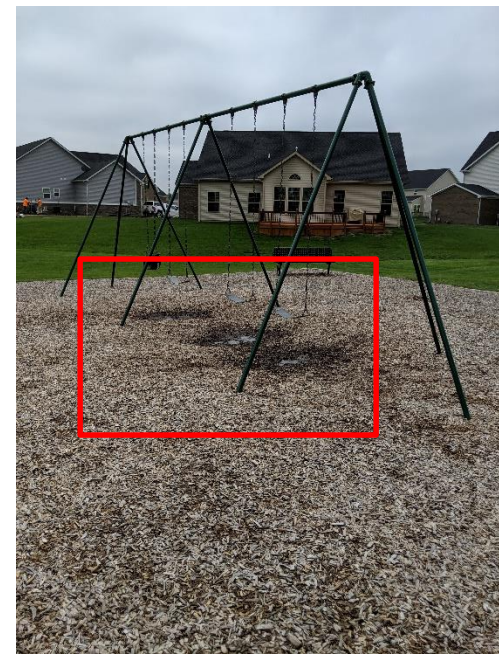
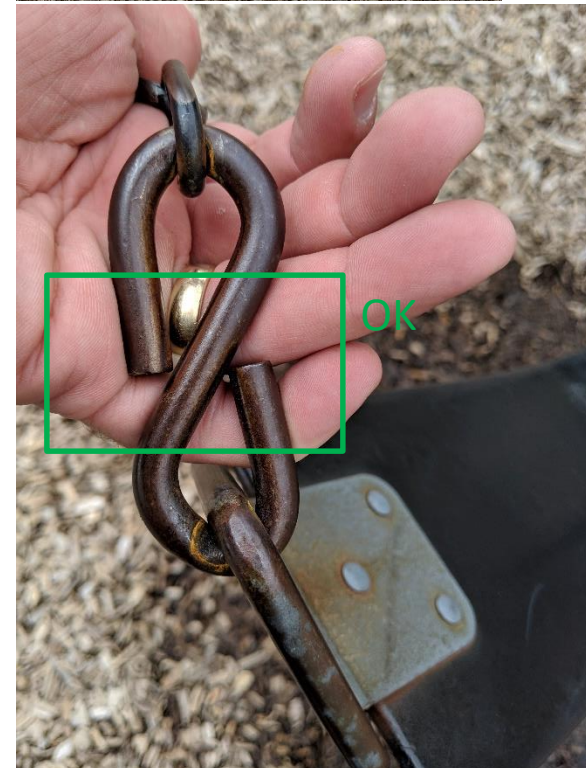
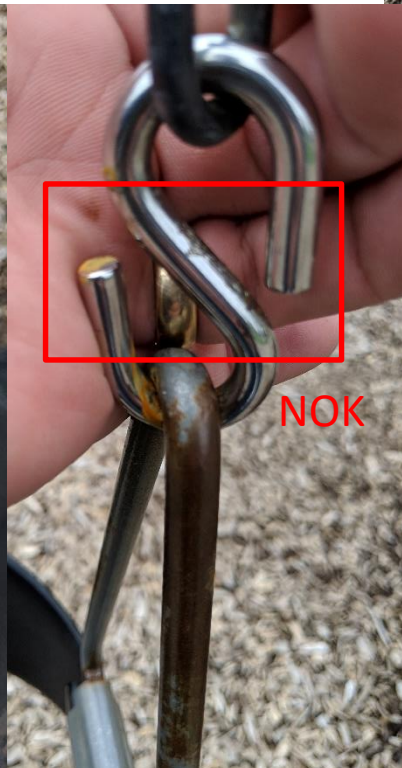
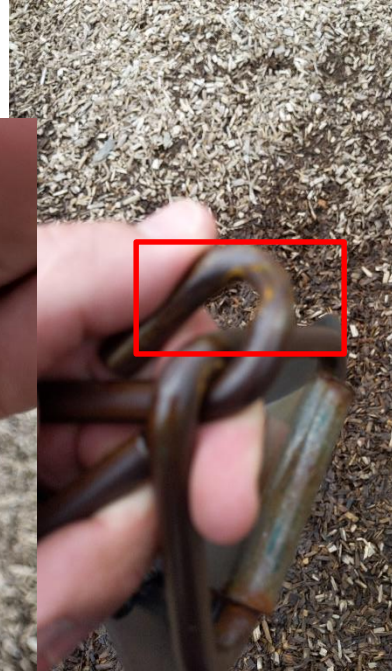
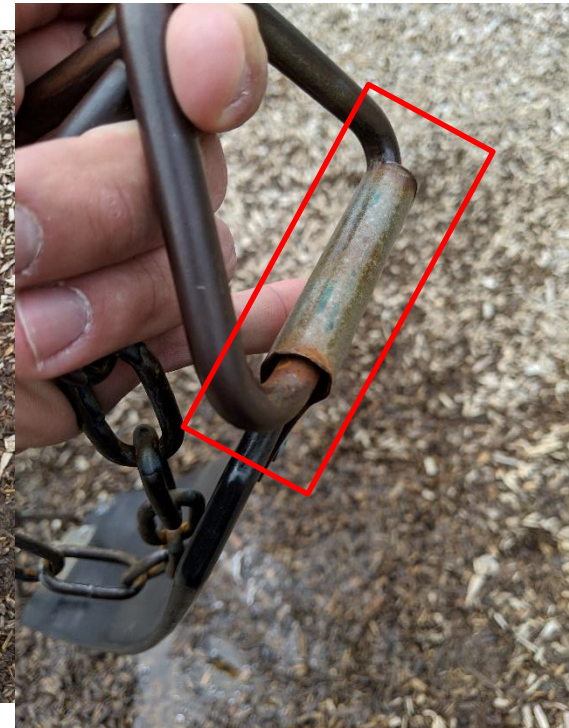
1. Mulch needed. Recommend swing mats
 1. Priority 2
2. S hook must be closed
 1. Priority 2
3. Swing seat connection points starting to wear. Replace with new chains and seats (10')
 1. Priority 4
